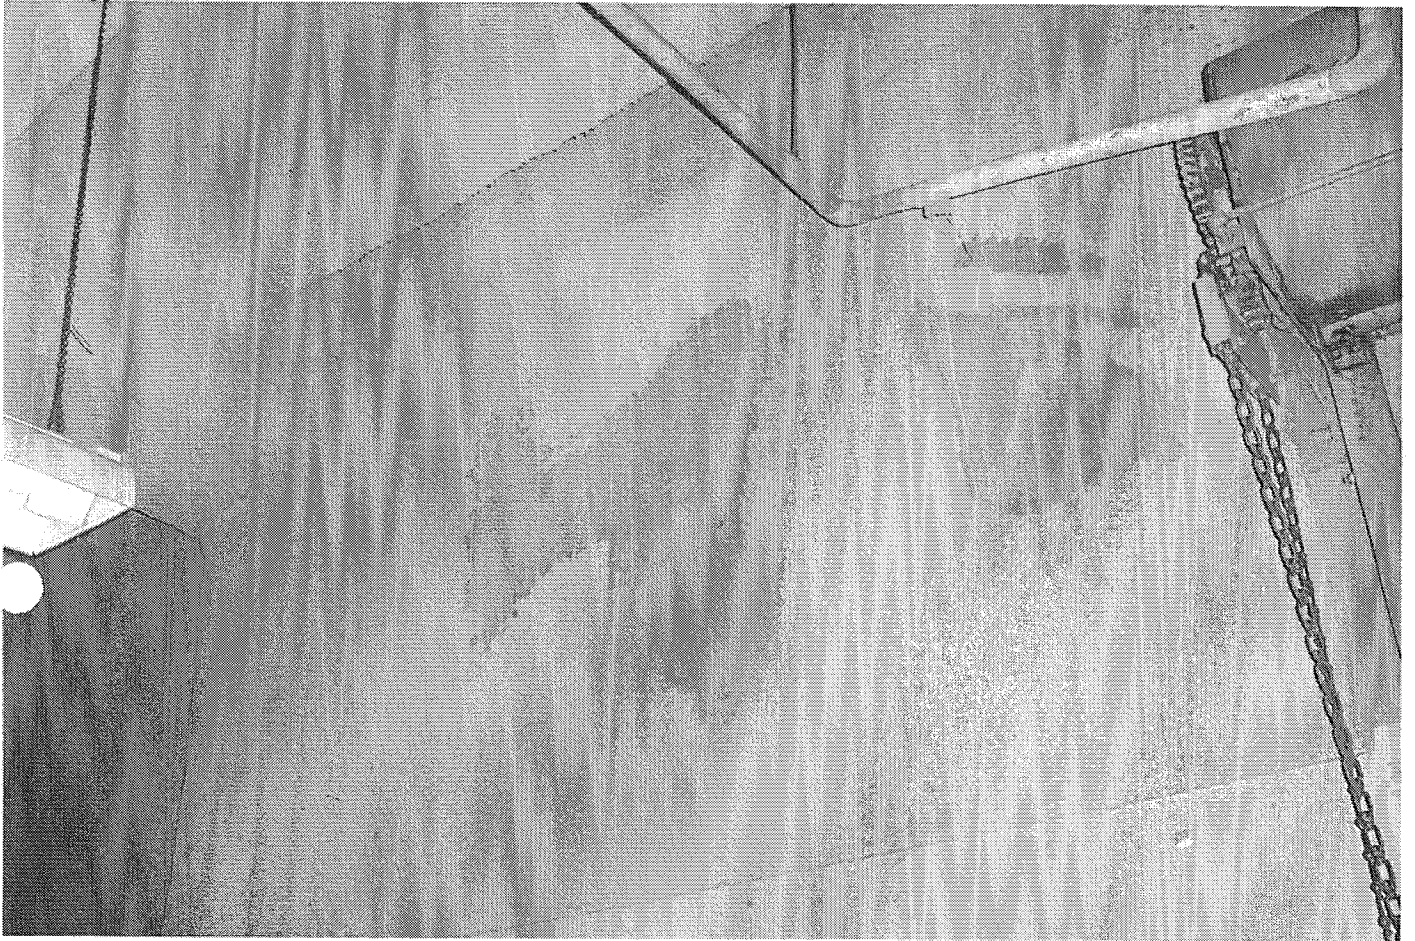
7. Main Terminal, Basement, Mechanical Rm - General view of impacted fireproofing applied to upper concrete wall (in storage area)

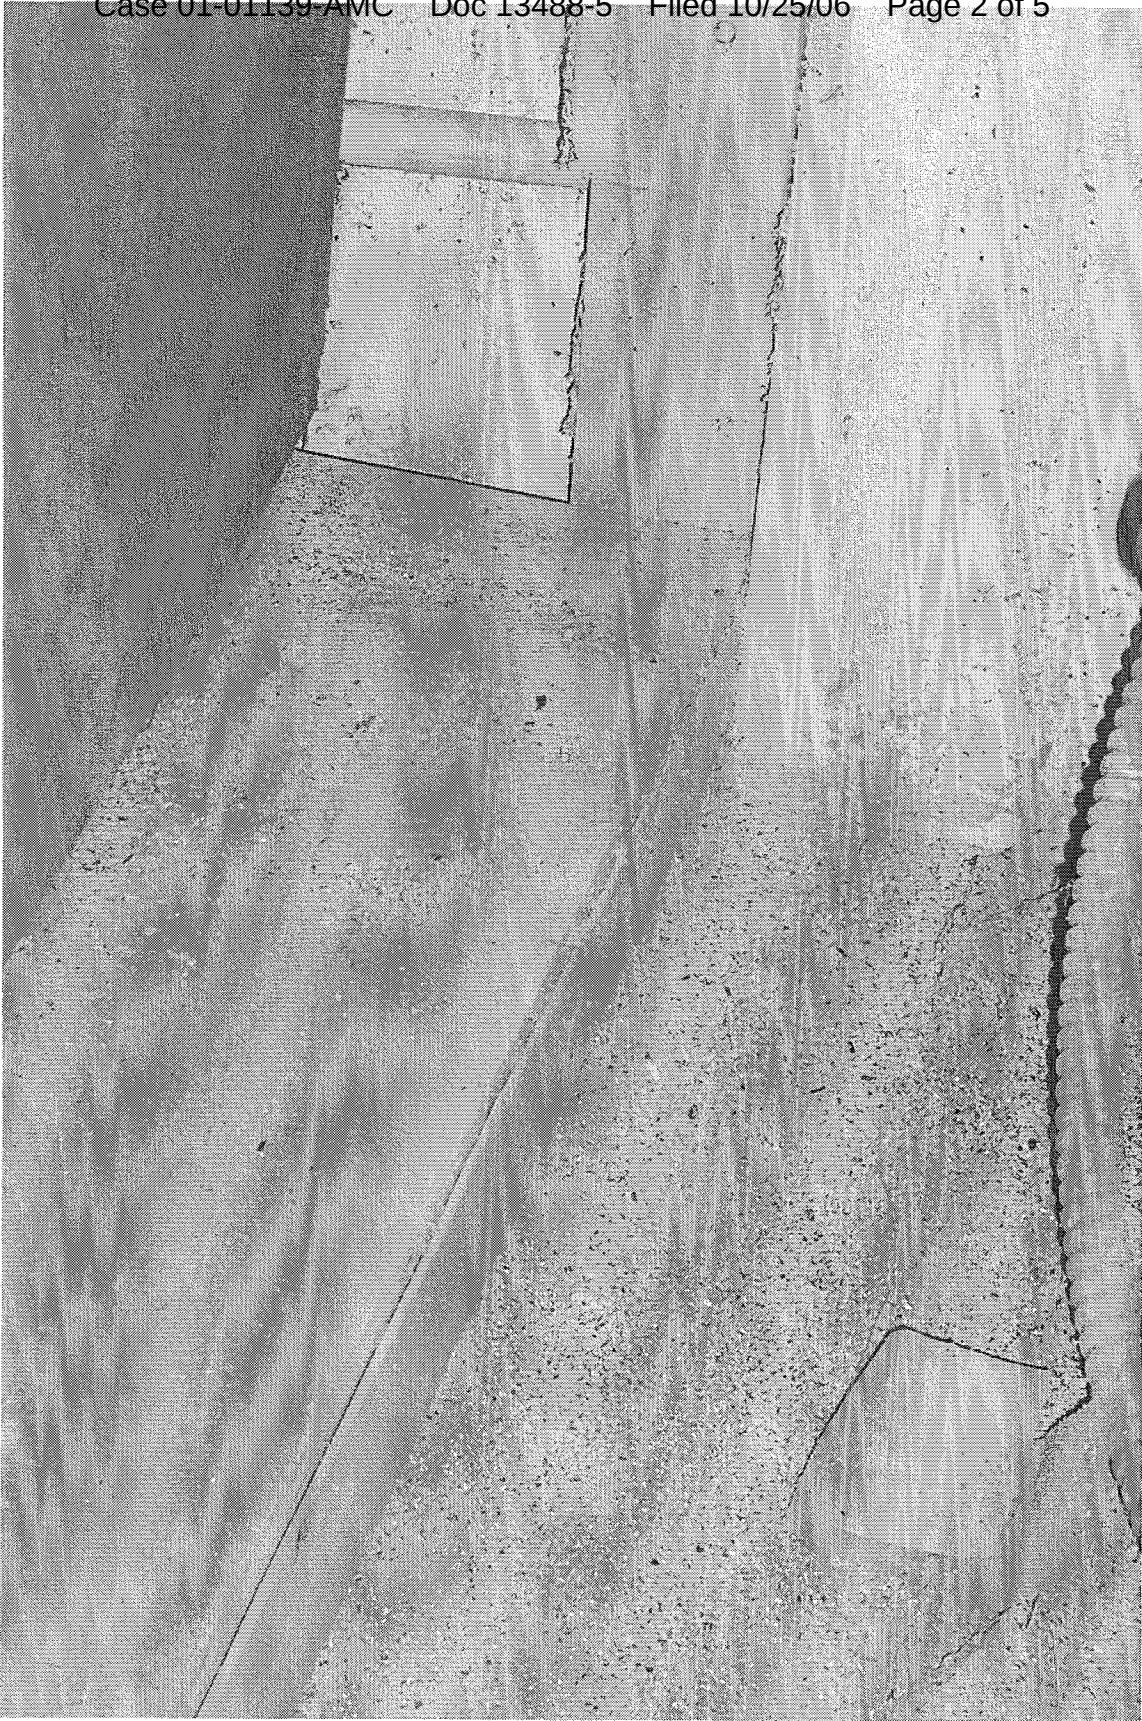
8. Main Terminal, Basement, Mechanical Rm - View of delaminated/dislodged fireproofing dust and debris on floor (in storage area)

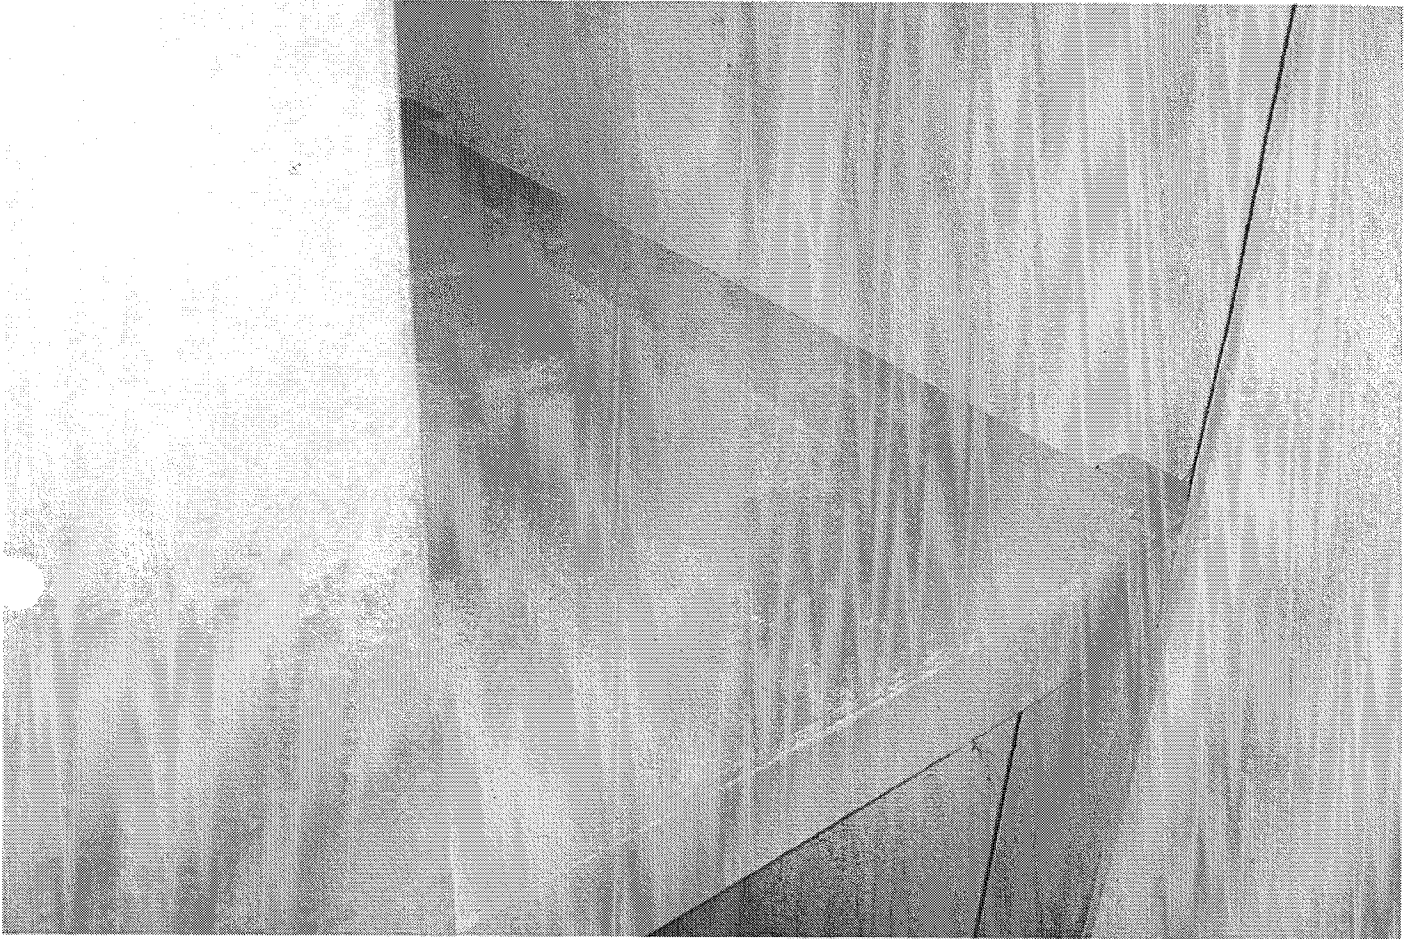
10. Main Terminal, Basement, Mechanical Rm - View of delaminated/dislodged fireproofing dust and debris on top of storage shelf

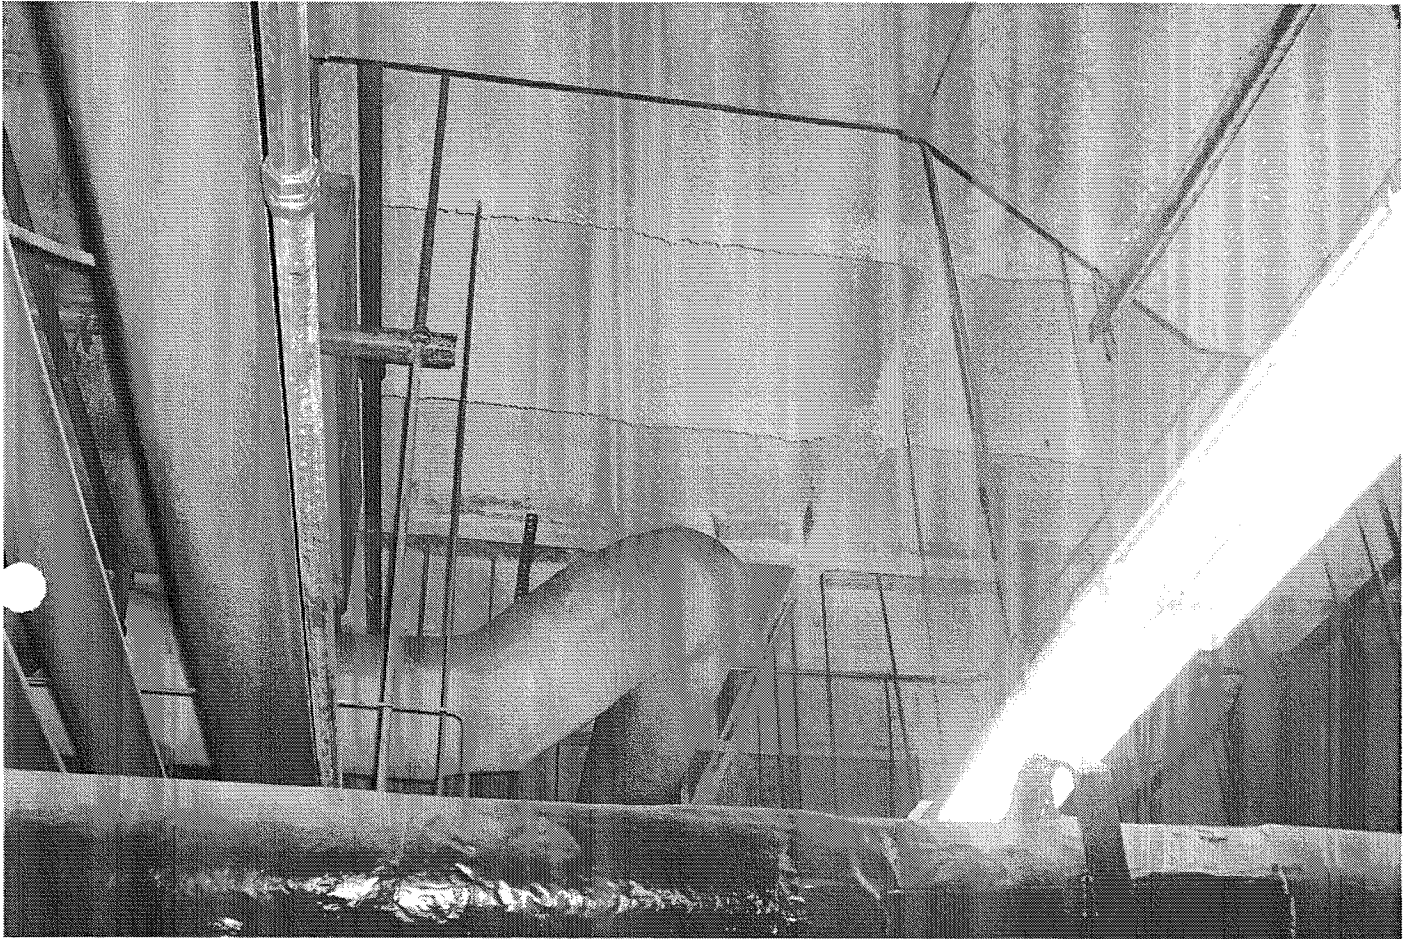
11. Main Terminal, Basement, Mechanical Rm - General view of fireproofed concrete decking above main mechanical room
